**DIAGNOSTIC AND FEASIBILITY STUDY
ASHMERE LAKE
Hinsdale, Massachusetts**

Prepared For: **Town of Hinsdale**
John A. Eagar
Lake Management Committee
P.O. Box 657
Hinsdale, Massachusetts 01235

Prepared By: **ESS Group, Inc.**
888 Worcester Street, Suite 240
Wellesley, Massachusetts 02482

Date: **May 31, 2003**

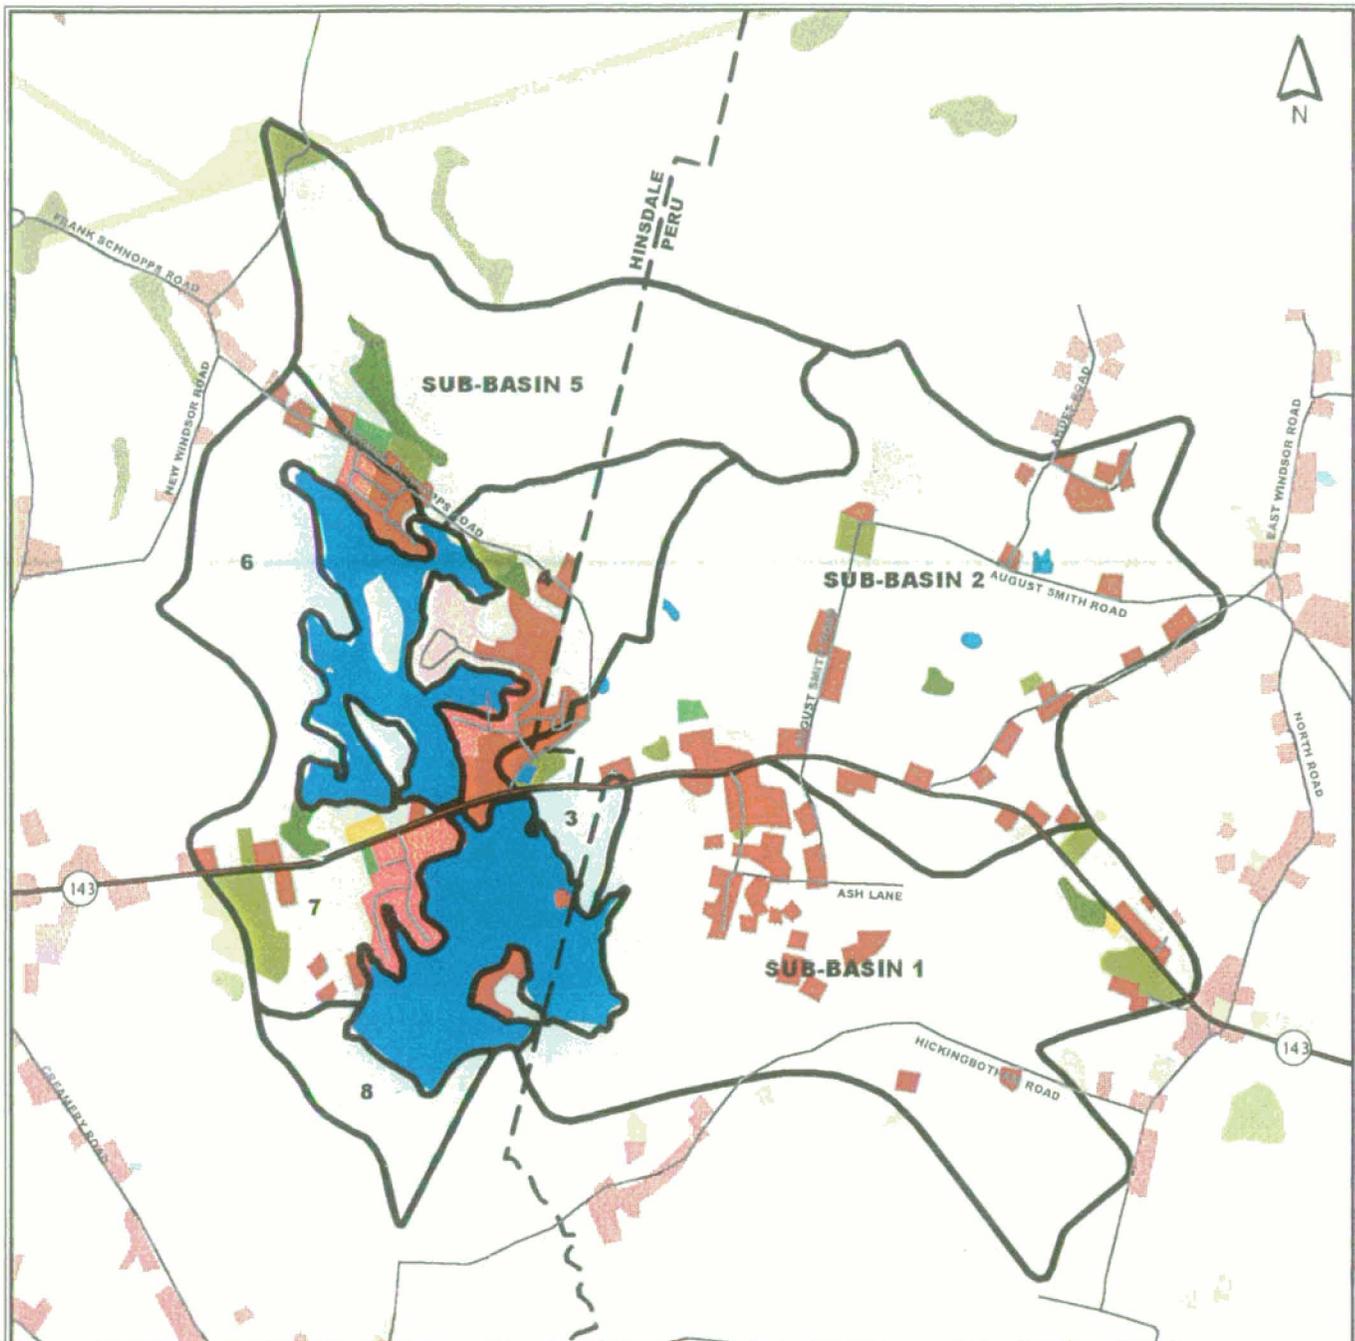
Land Use Classification			
	Major Roads		Residential (R1) (25.0 Acres)
	Road Network		Residential (R2) (50.2 Acres)
	Town Boundaries		Residential (R3) (219.6 Acres)
	Ashmere Watershed Boundary		Commercial (4.4 Acres)
			Urban Open (8.4 Acres)
			Water (269.5 Acres)
			Cropland (2.9 Acres)
			Pasture (29.6 Acres)
			Forest (2,048.2 Acres)
			Wetland (28.2 Acres)
			Open Land (62.6 Acres)
			Participation Recreation (75.4 Acres)

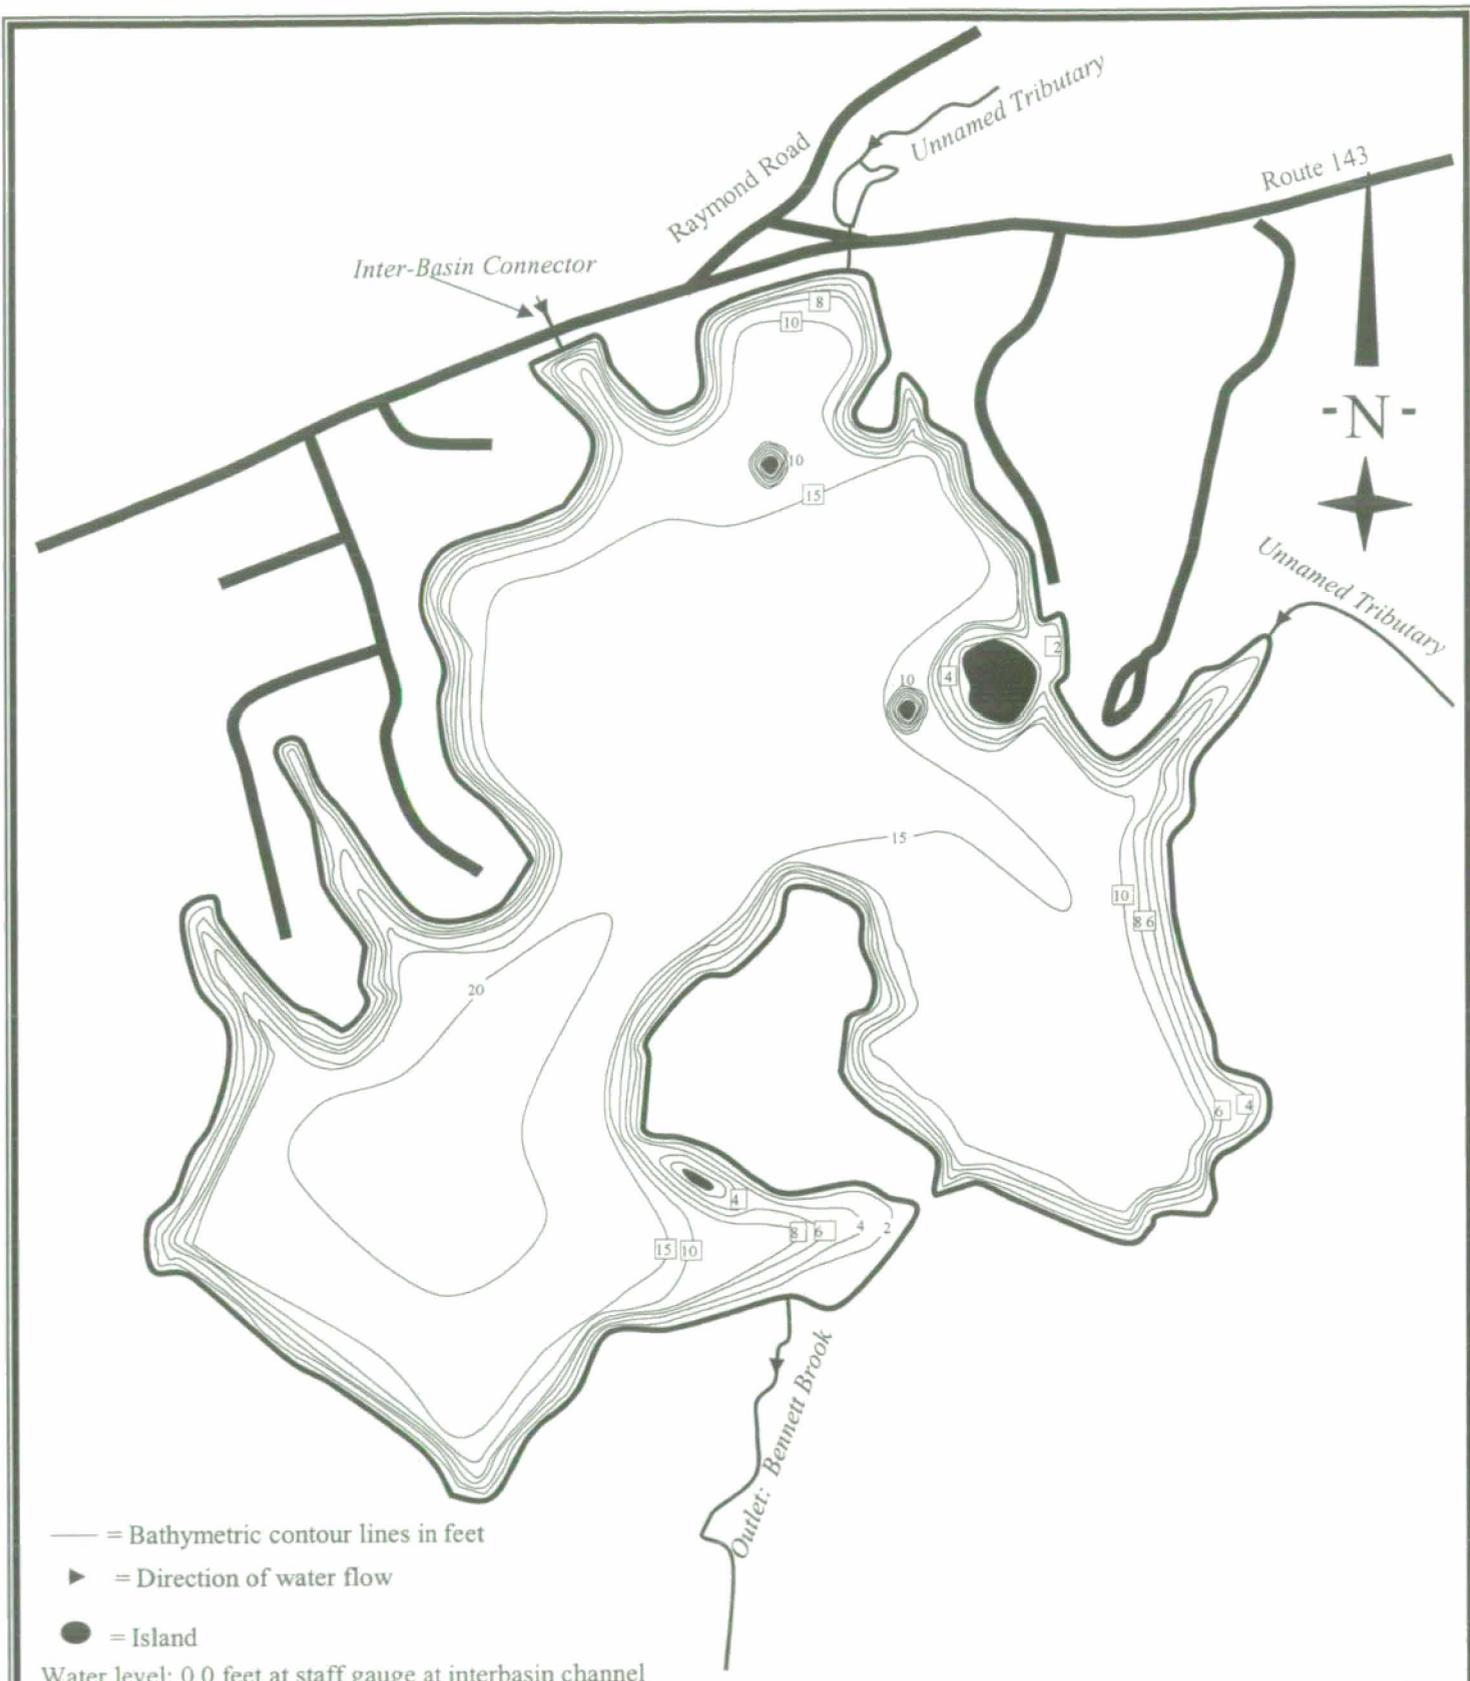
- = Bathymetric contour lines in feet
- ▶ = Direction of water flow
- = Island

Water level: 0.0 feet at staff gauge at interbasin channel

Water depths in the lake were measured along 10 appropriately spaced transects within each basin on May 20th, 2002. The maximum depth observed was 24 feet in the south basin and 14 feet in the north basin, with an average water depth of 13 and 6.5 feet for the south and north basins, respectively (average water depth for the entire lake is 10.7 feet; Table 2). Calculations based on our bathymetric survey indicate that the lake has an approximate volume of slightly greater than 119 million cubic feet of water (Table 2).

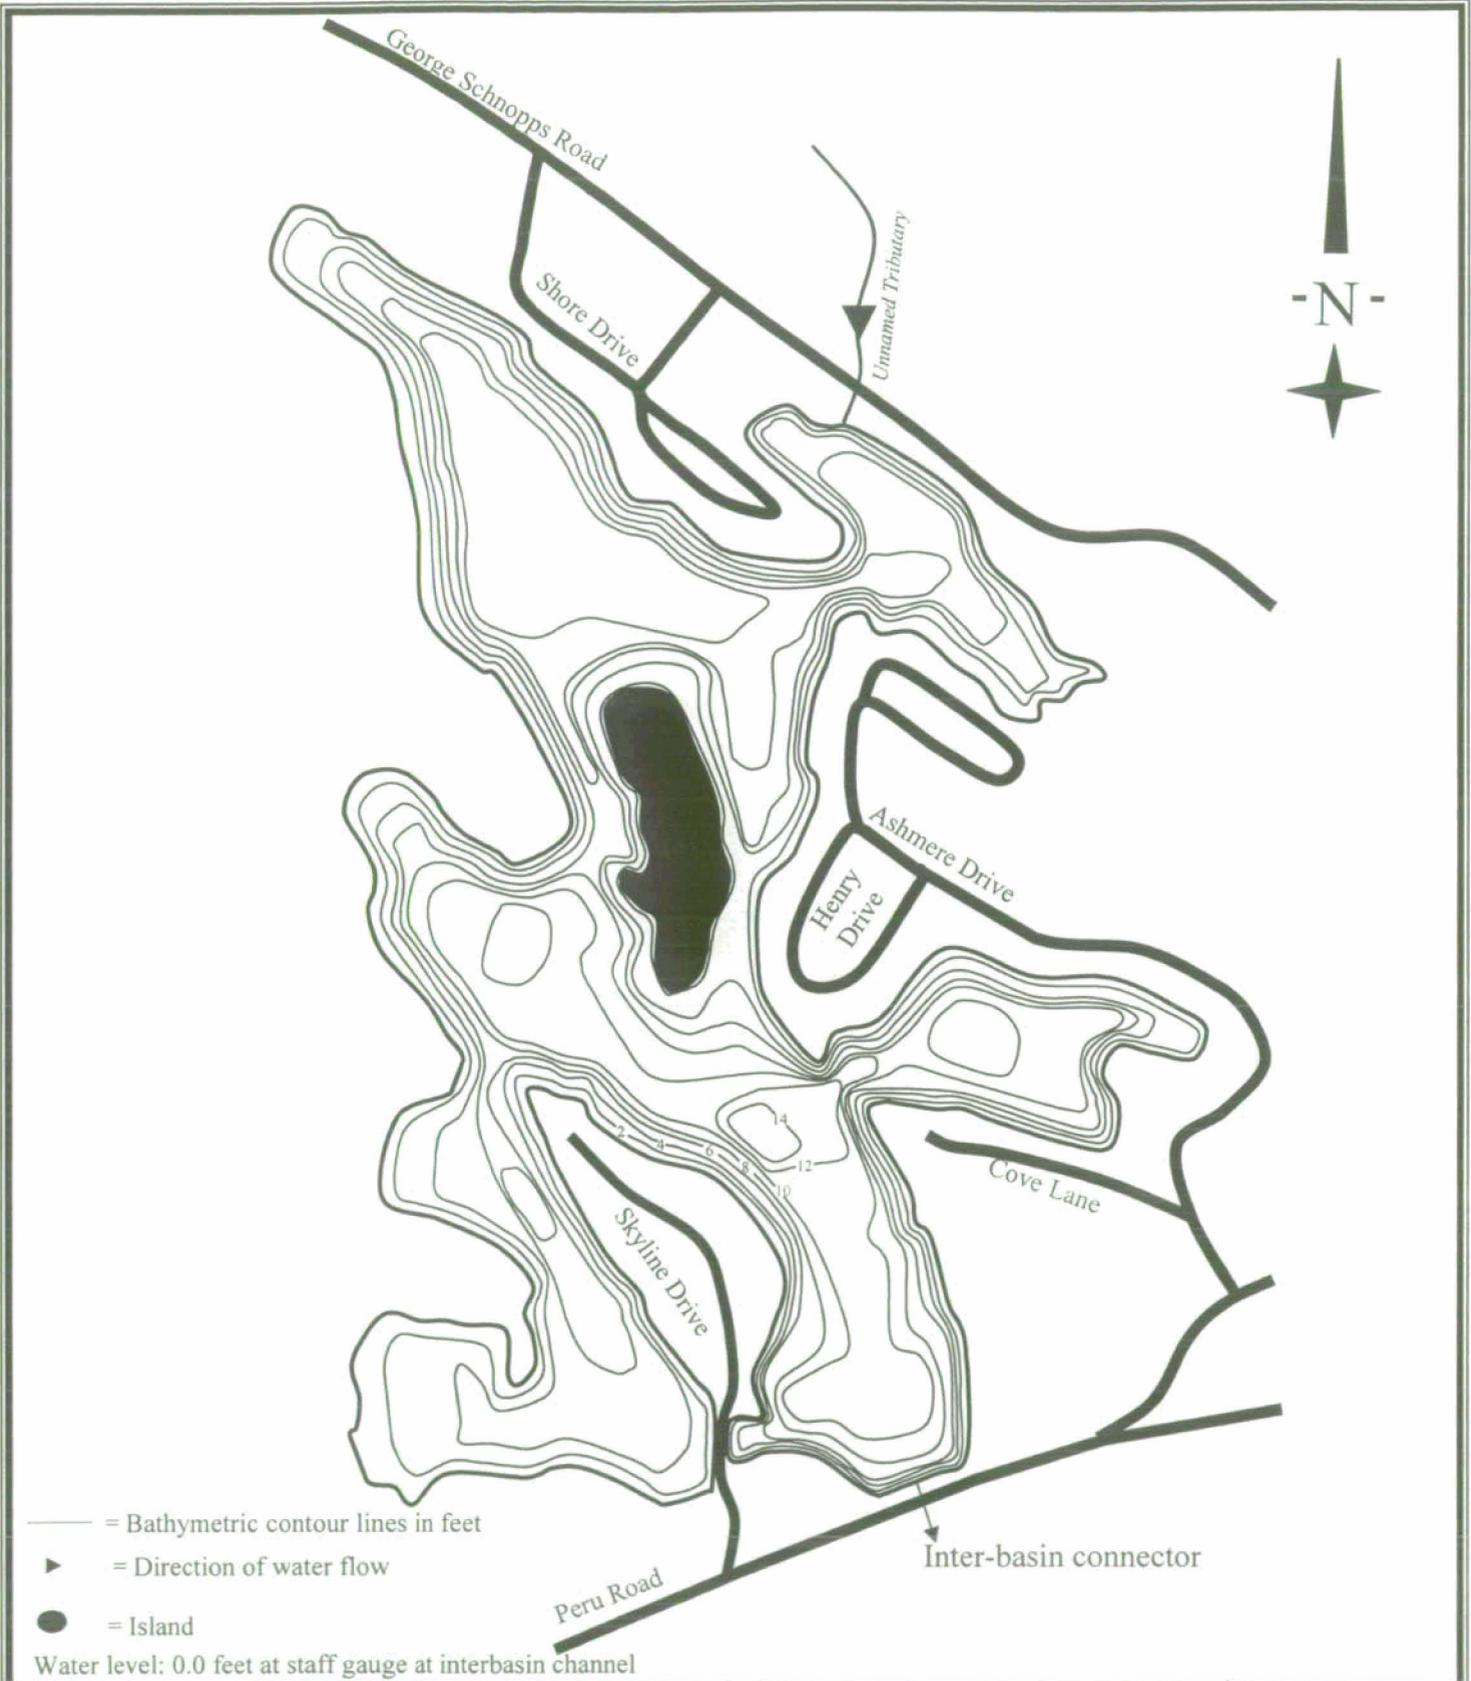
- = Bathymetric contour lines in feet
- ▶ = Direction of water flow
- = Island

Water level: 0.0 feet at staff gauge at interbasin channel

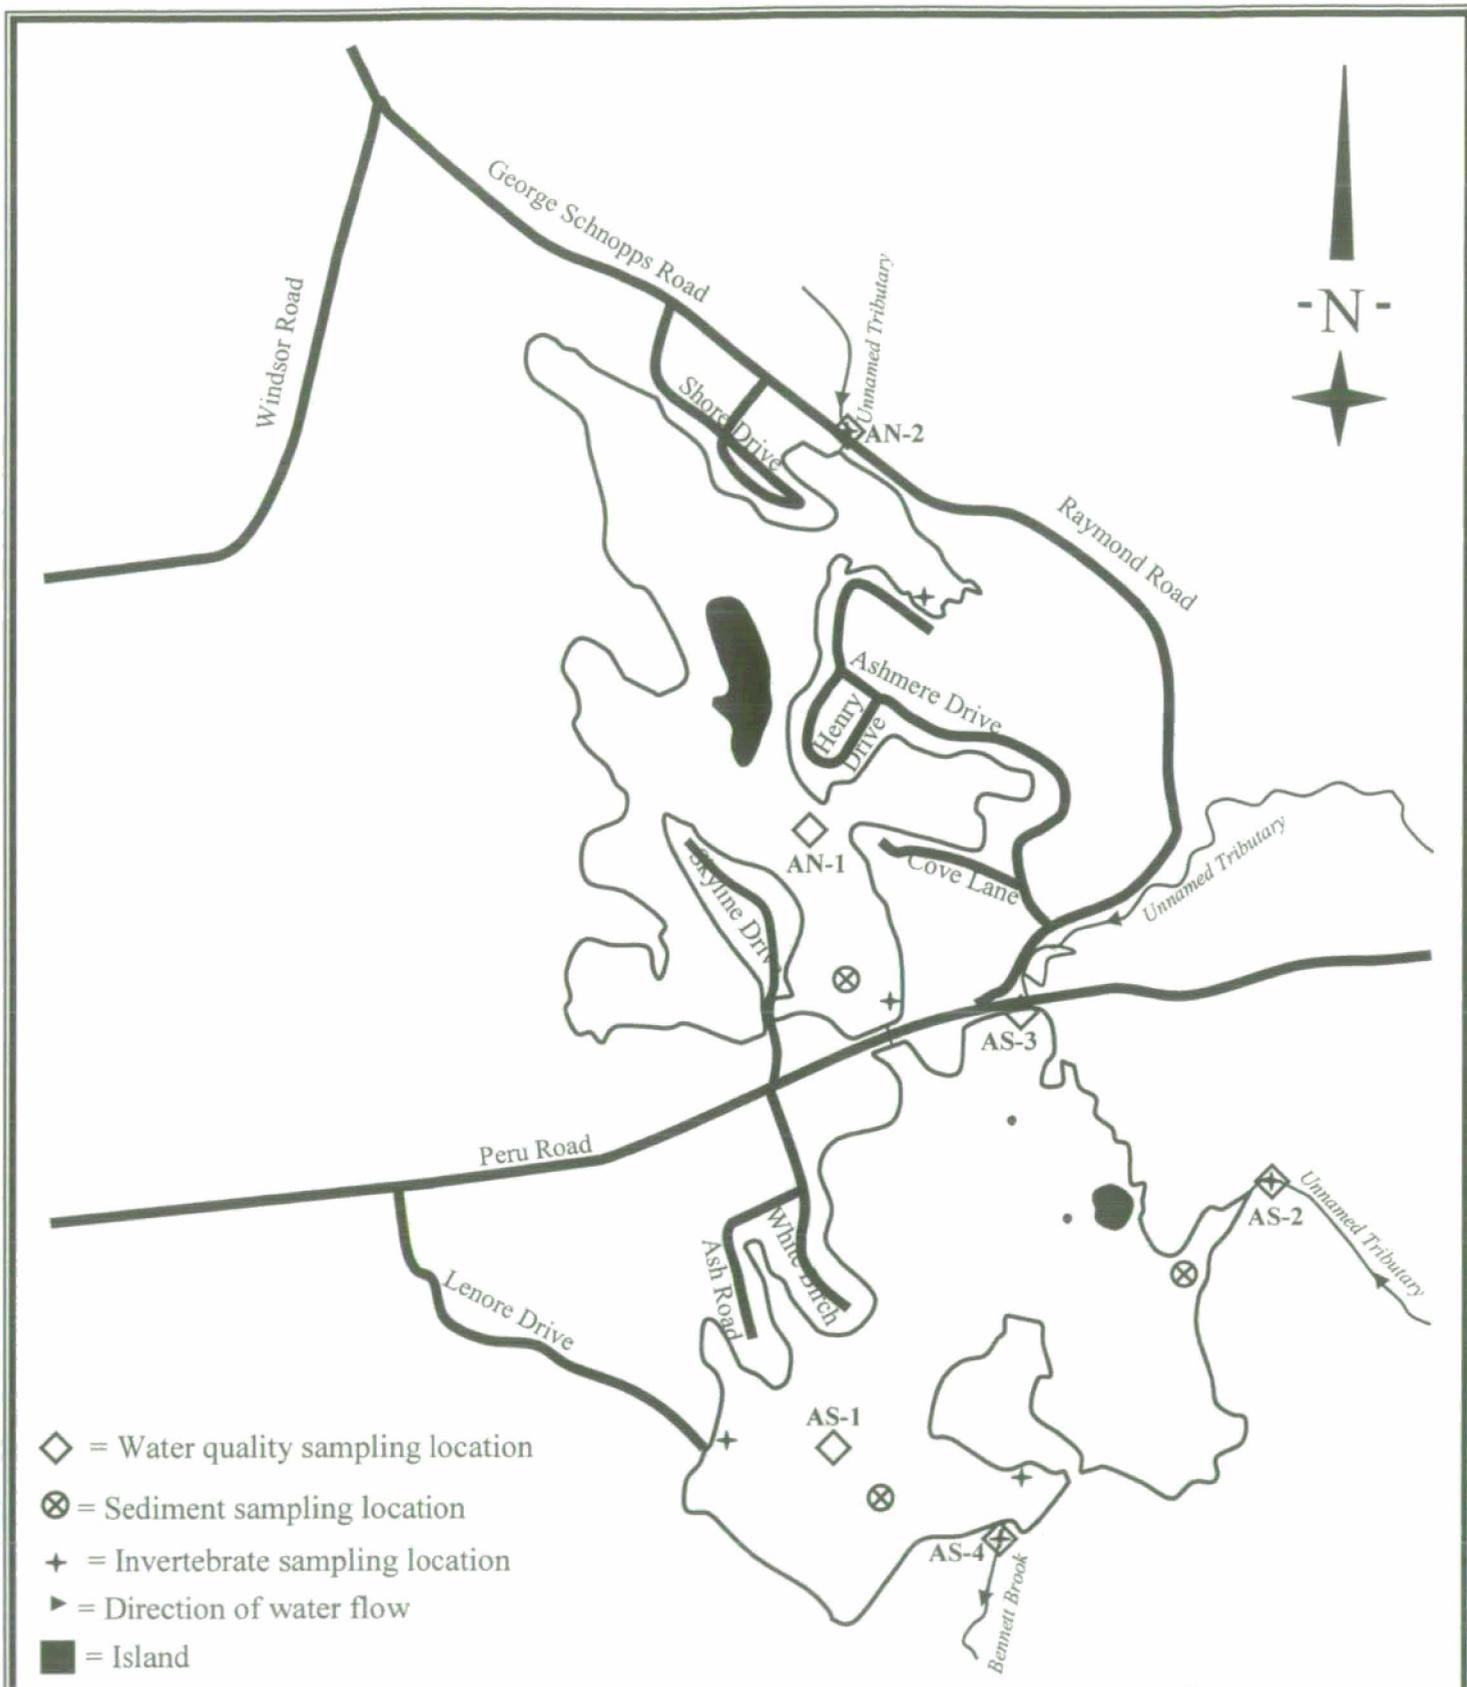
FIGURE NO.
5
 PROJECT NO.
 H119-000

Water Quality, Sediment and Invertebrate Sampling Locations
Ashmere Lake
Hinsdale, Massachusetts

- Water samples were collected in order to characterize water quality conditions from in-lake stations, the major tributaries, a significant stormwater outfall and immediately downgradient of the lake's outlet. Sampling water quality from these locations allows for lake managers to quantify and prioritize sources of pollution entering the lake and provides insight into in-lake chemical and physical processes that ultimately affect a lake's overall hydrologic and nutrient budget. The following water quality parameters were assessed during each field visit, as applicable: Secchi disk transparency, temperature, dissolved oxygen, conductivity, fecal coliform, total alkalinity, total phosphorus, dissolved phosphorus, nitrate nitrogen, total Kjeldahl nitrogen, ammonia nitrogen, pH, flow rate and turbidity.

Average pH values exhibited at the in-lake stations ranged from 7.2 to 7.4 SU (Table 4). Average pH values measured at the tributary stations (AS-2 & AN-2), the storm drain, (AS-3), and the outlet (AS-4) are 7.0, 7.4, 7.9, and 6.7 SU, respectively (Table 4). The range of pH values exhibited during this study do not appear to indicate any adverse pollutant loading; however, the sample collected from the storm drain site does seem to exceed the background levels observed within the lake itself.

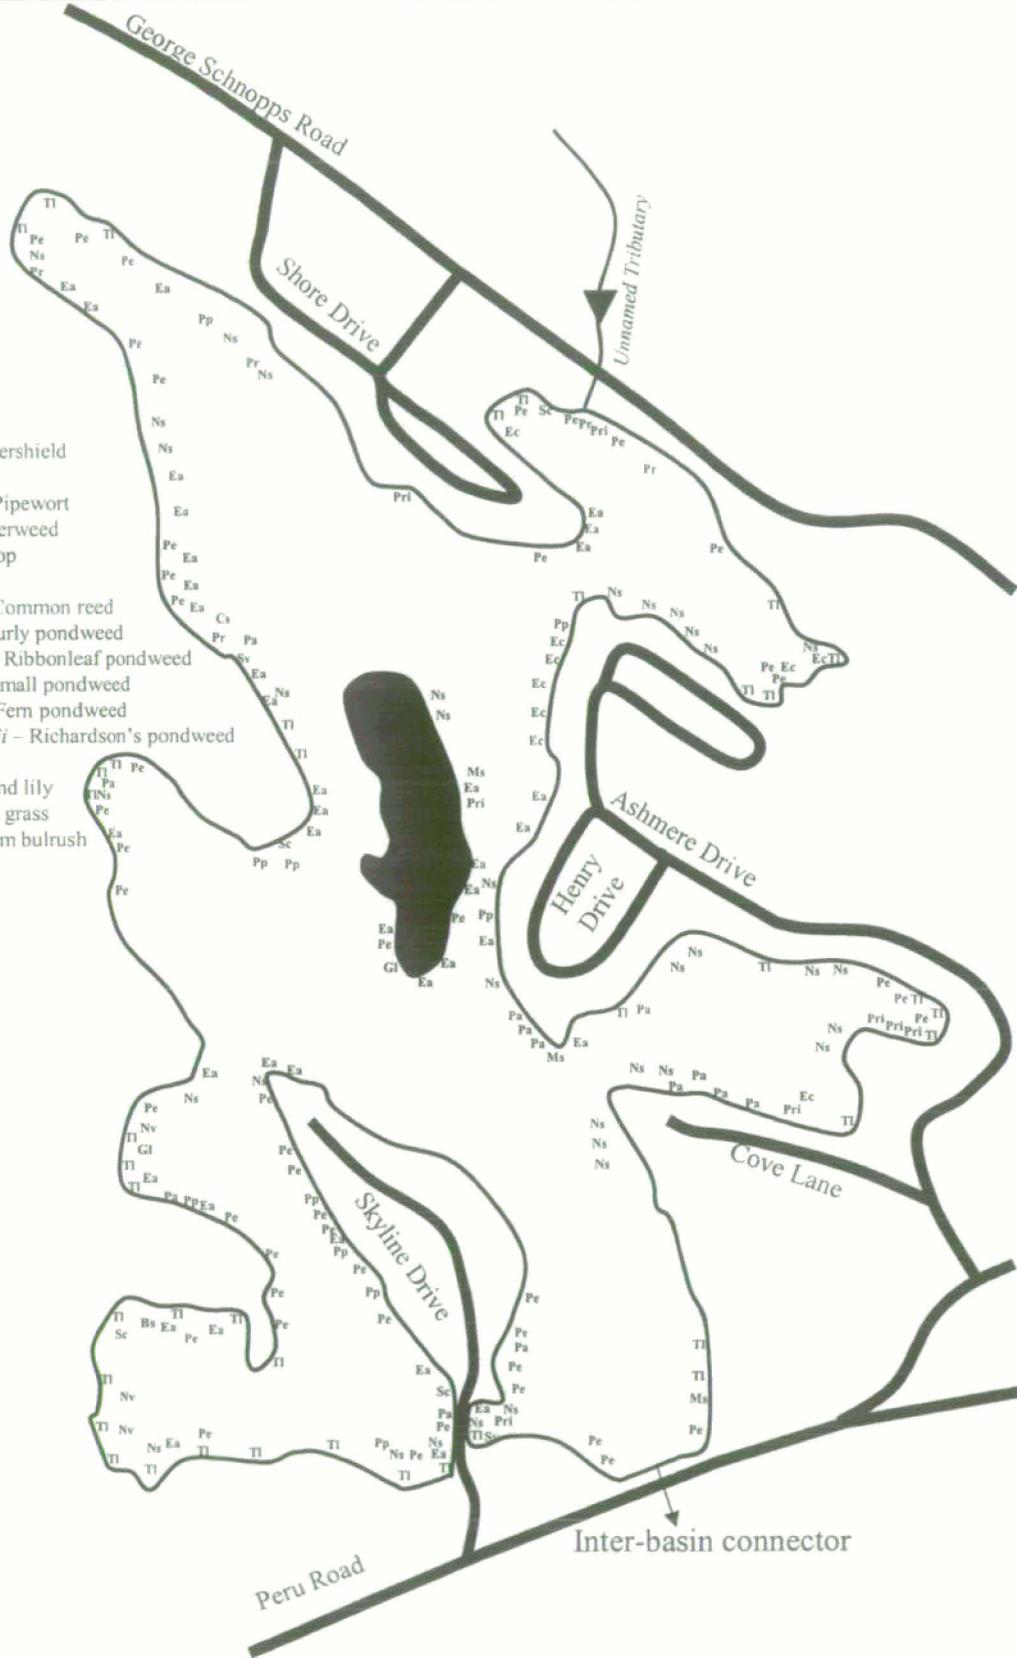
Dominant Plant Species
Ashmere Lake, North Basin
Hinsdale, Massachusetts
8/26/02

The greatest abundances of aquatic plants observed throughout the study were reported from the north basin of Ashmere Lake on August 26th, 2002. Dominant plant species observed within the north basin include ribbonleaf pondweed (*Potamogeton epihydrus*), cattail, pipewort, stonewort, fern pondweed and

The aquatic plant abundance documented on August 26th, 2002 indicates that although an herbicide treatment was conducted on June 4th, 2002, it appears that the plant communities in both the north and south basins of Ashmere Lake continued to develop throughout the growing season. In fact, the greatest plant abundance was observed during our post-treatment survey in the more extensively treated north basin of Ashmere Lake. The fact that most plant growth observed within the lake were native species appears to indicate that herbicide treatments are not having an impact on the native plant community.

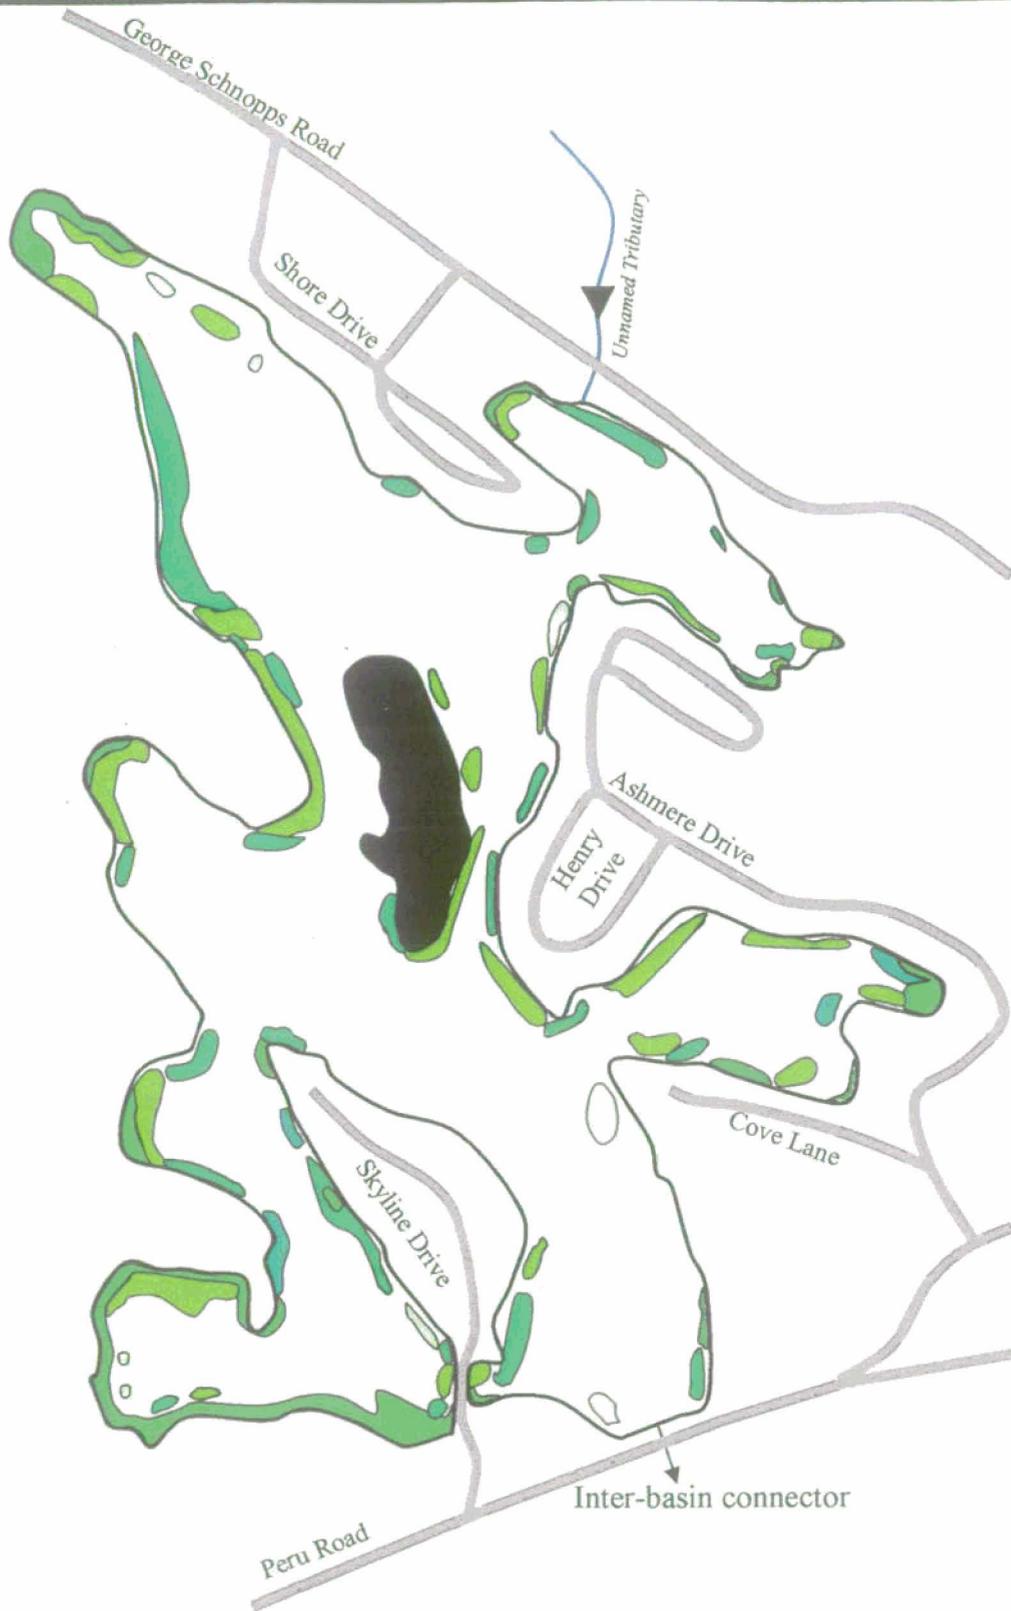
Percent cover

- 0%
- 1% - 25%
- 26% - 50%
- 51% - 75%
- 76% - 100%
- Island

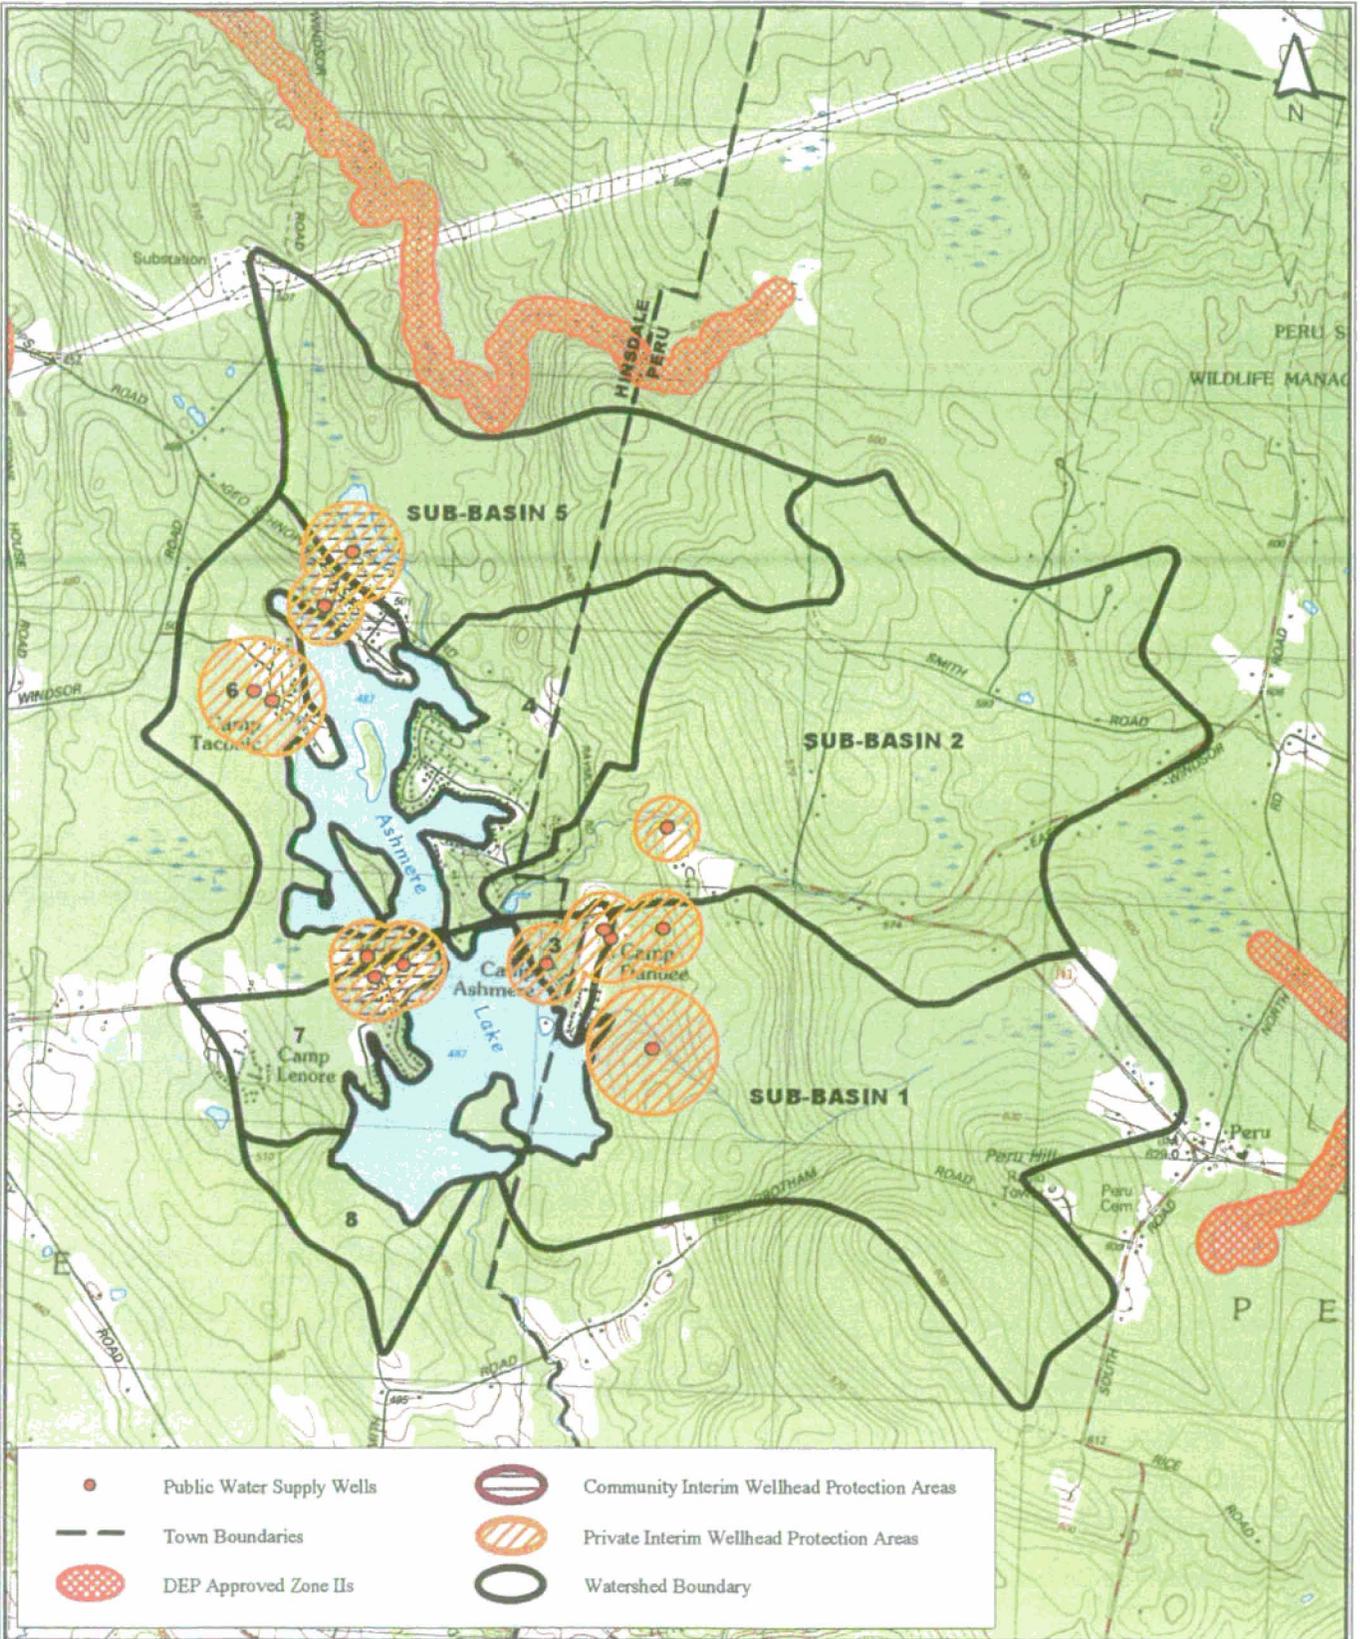
Water Resources of the Ashmere Lake Watershed

Source: 1) MassGIS, DEP Approved Zone IIs, 2002
 2) ESS, Ashmere Watershed Delineation, 2002 3) MassGIS, USGS DRG, 1988
 4) MassGIS, Public Water Supply Wells
 Scale: 1" = 2,500'
 Ashmere Lake Diagnostic and Feasibility Study Plan
